68, 70, 72 and 74 Wellington Street, Thame
Remediation Summary Statement
South Oxfordshire District Council

Report Title: **68, 70, 72 and 74 Wellington Street, Thame
Remediation Summary Statement**

Revision: **B**
Issue Date: **February 2012**
Report Ref: **AG/2911/111201/RSS/T/B**

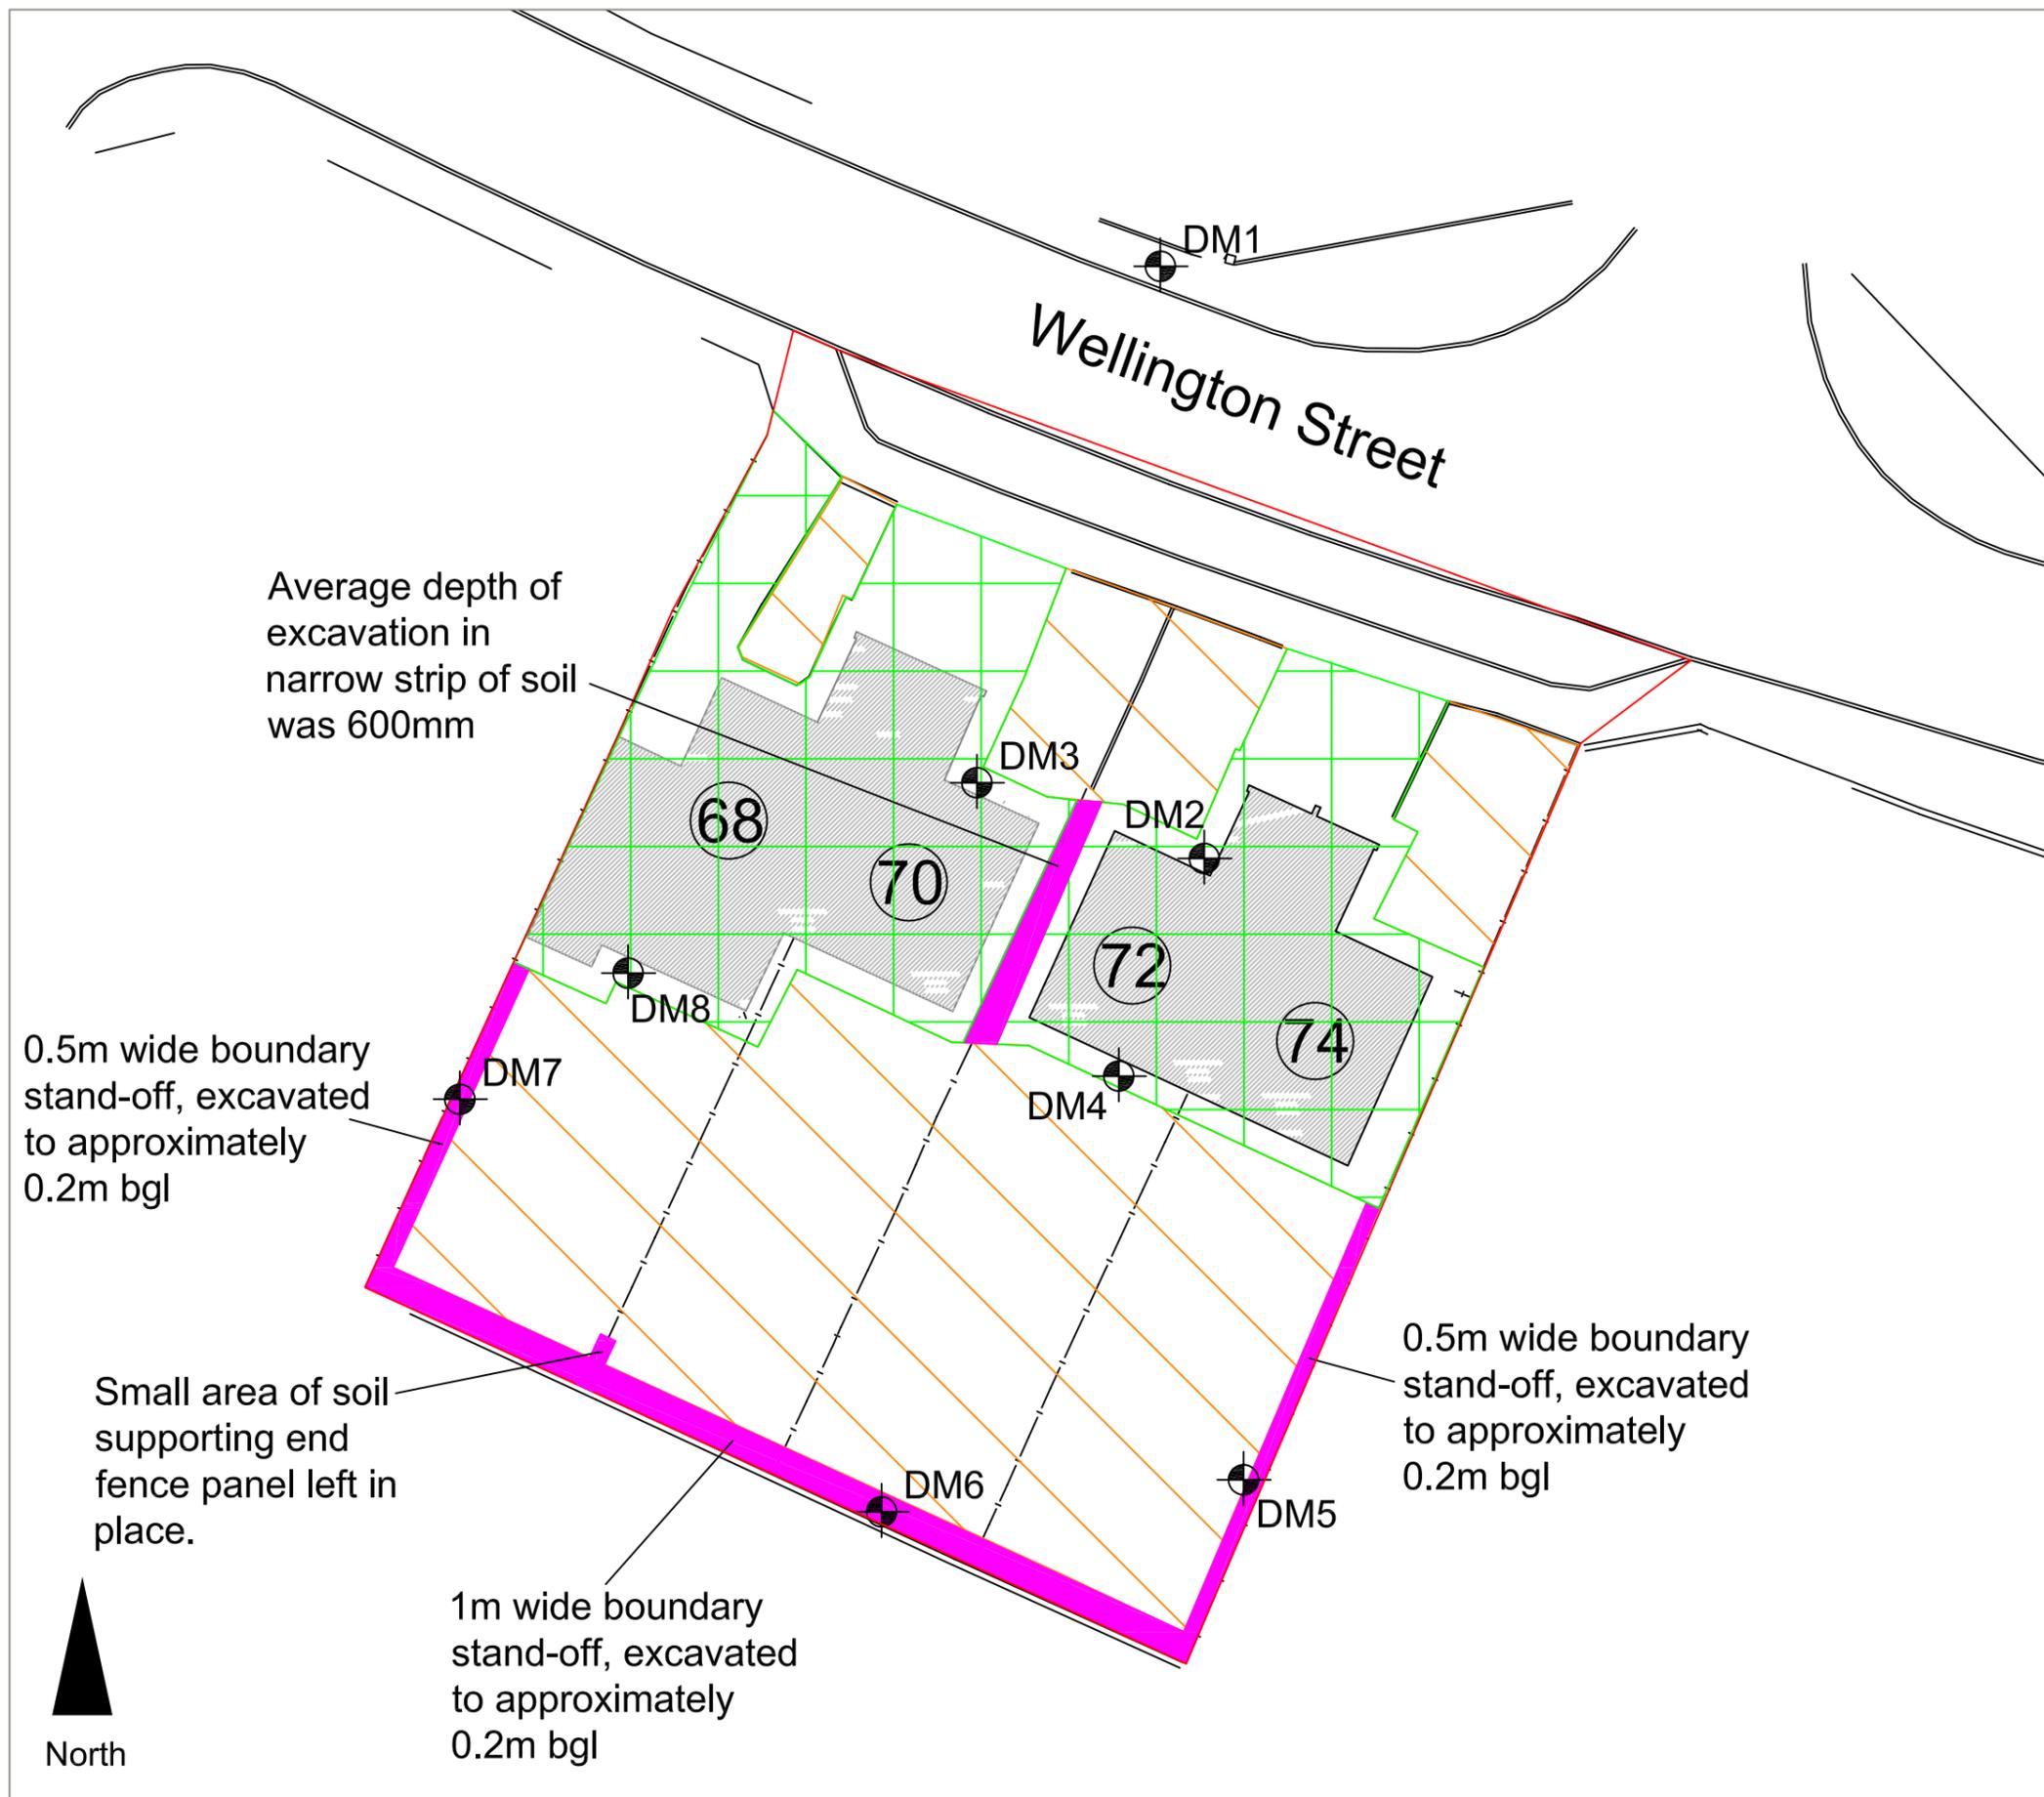
Remediation Features Plan

- 3.2.3 Those areas of the site where excavation of existing soils to 750mm below ground level was not possible are indicated on Figure A3, Appendix A. This area equates to 7% of the garden areas. Calculations show that there is no risk to the health of residents from soils remaining in the gardens on the site.

6.3.4 The areas in which complete excavation was not undertaken, and therefore in which existing soils may remain within 750mm of the ground surface are shown on Figure A3, Appendix A.

6.3.5 Where excavating within the areas highlighted in Figure A3, the following precautions should be undertaken:

- Gloves should be worn when contact with the soils could occur;
- Any soil that is attached to clothes, boots, etc., should be removed before they are taken indoors;
- There should be no eating, drinking or smoking when working in contact with soils;
- Any contractors employed to undertake works involving excavation in the future should be given a copy of this document so that they are aware of the precautions that they should adopt;
- If any building or excavation works that may extend deeper than 750mm below ground level in garden areas are planned, South Oxfordshire District Council must be contacted for advice.
