**14, 16, 18, 20 and 22 Church Street, Watlington**  
**Remediation Summary Statement**  
**South Oxfordshire District Council**

**February 2012**

Report Title: **14, 16, 18, 20 and 22 Church Street, Watlington  
Remediation Summary Statement**

Revision: **B**  
Issue Date: **February 2012**  
Report Ref: **AG/2911/111207/RSS/W/B**

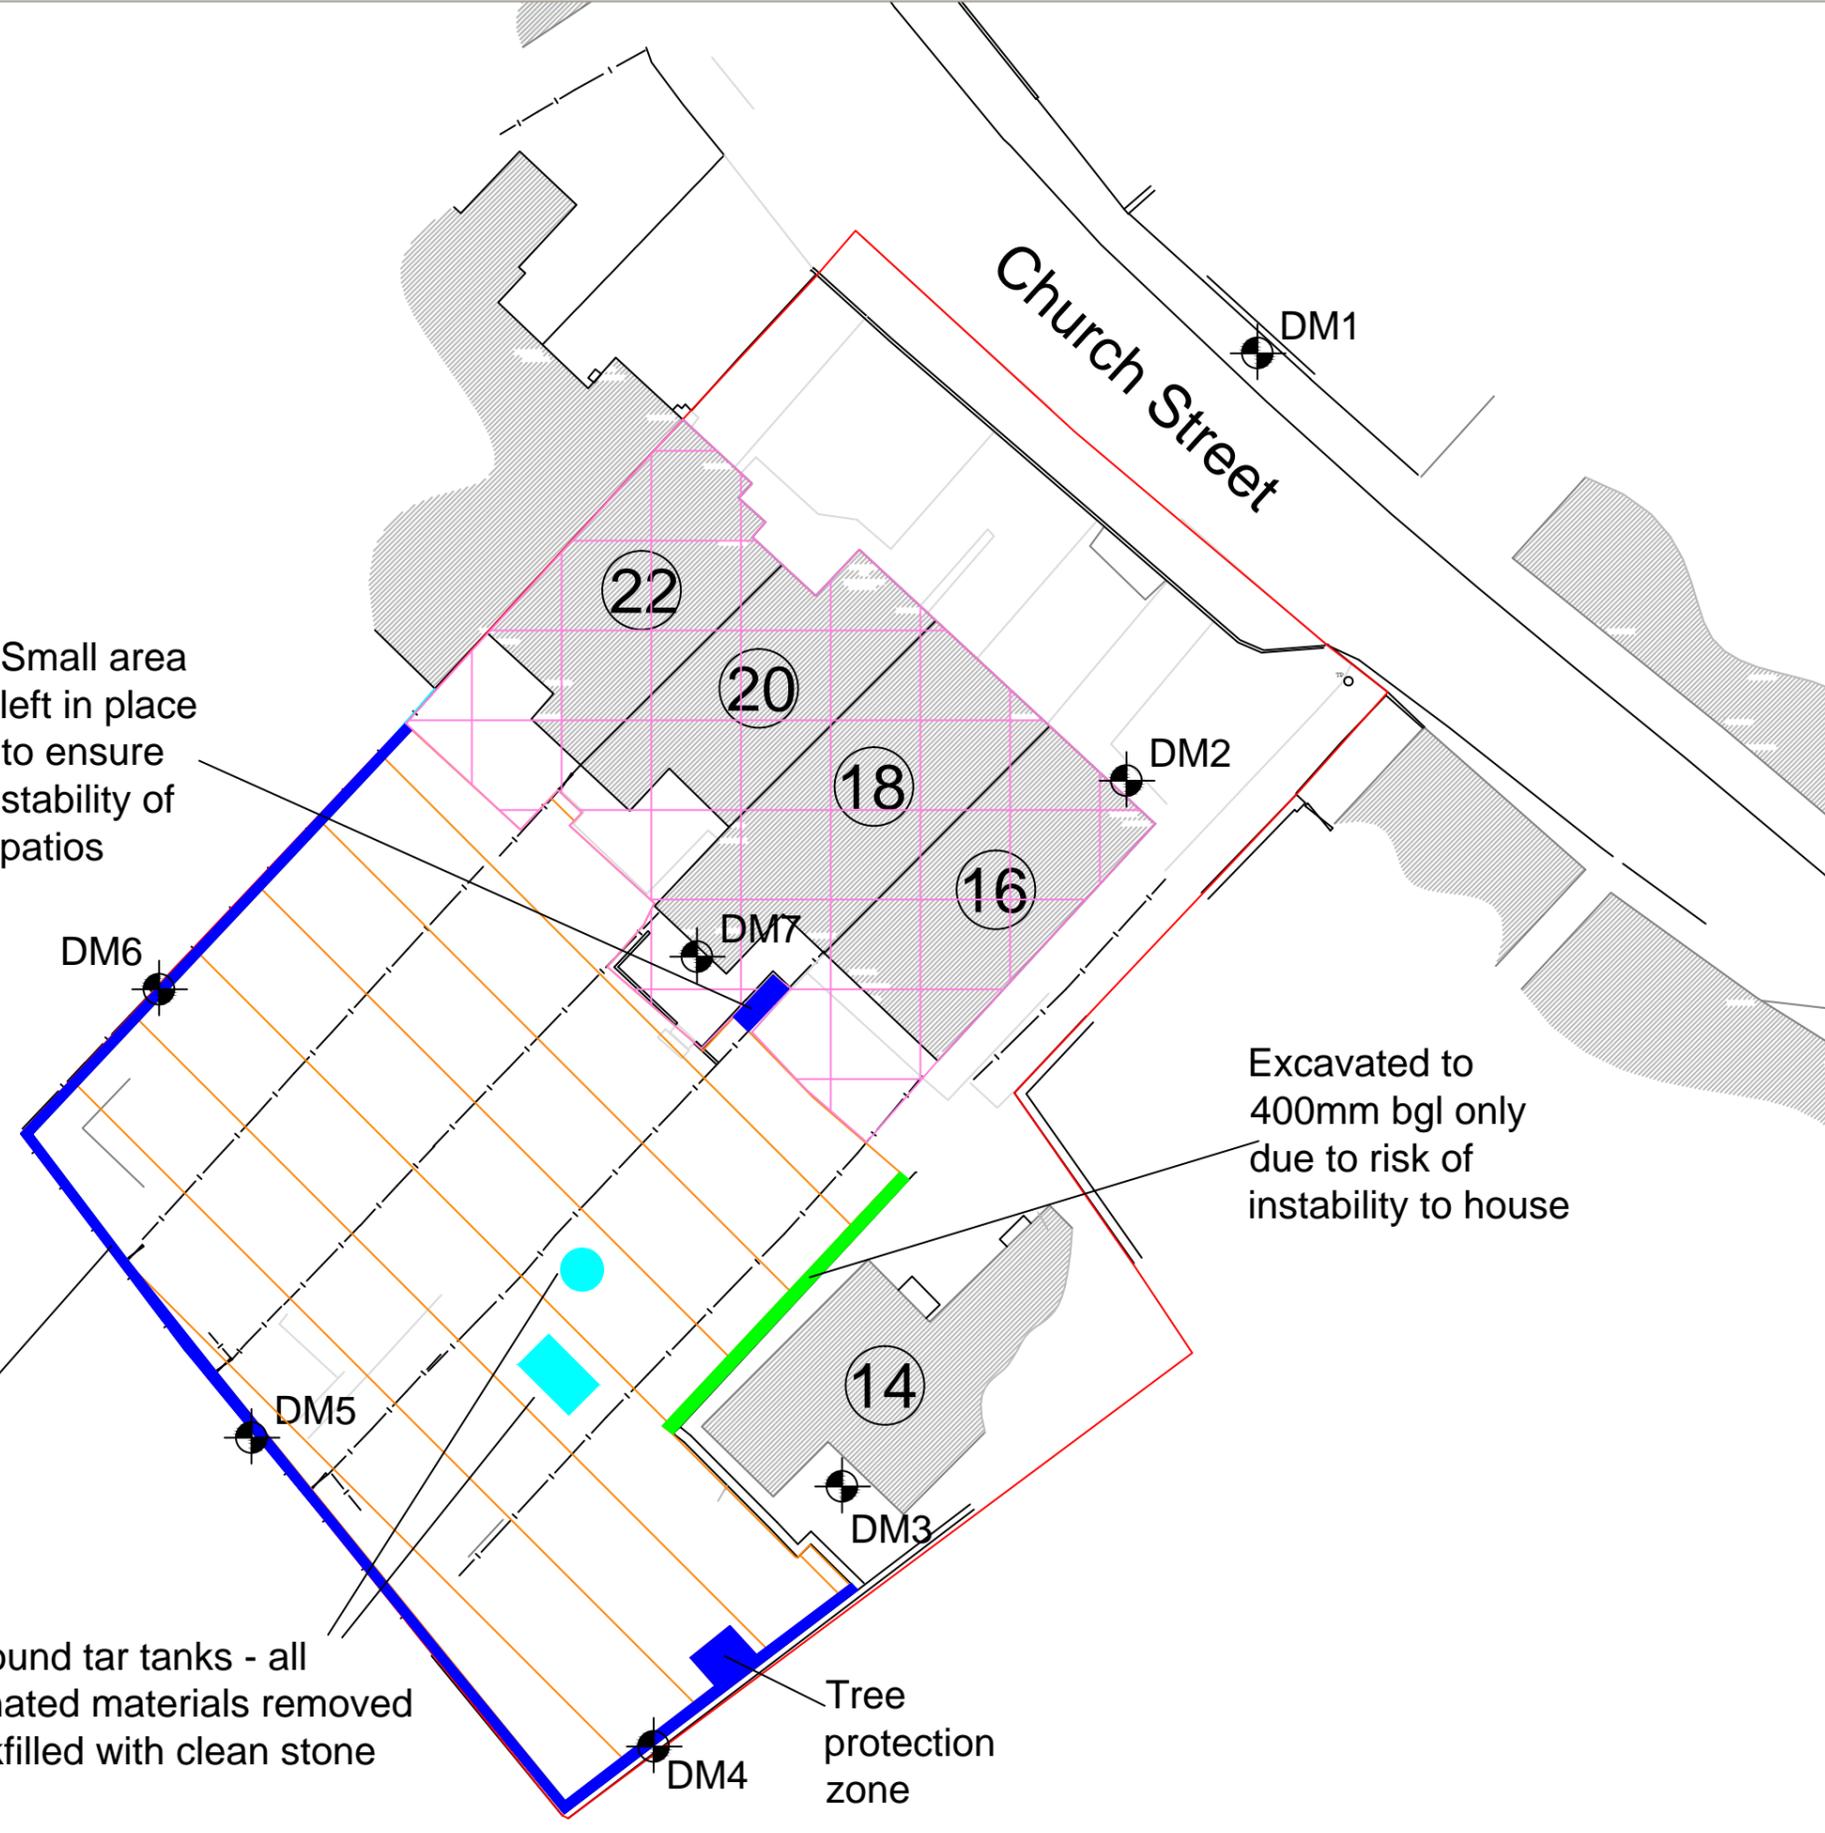
Remediation Features Plan

- 3.2.3 Those areas of the site where excavation of existing soils to 600mm below ground level was not possible are indicated on Figure A3, Appendix A. This area equates to 4% of the rear garden areas. Calculations show that there is no risk to the health of residents from soils remaining in the rear gardens on the site.

6.3.3 The areas in which complete excavation was not undertaken, and therefore in which existing soils may remain within 600mm of the ground surface are shown on Figure A3, Appendix A.

Small area left in place to ensure stability of patios

Underground tar tanks - all contaminated materials removed and backfilled with clean stone

Excavated to 400mm bgl only due to risk of instability to house

6.3.4 When digging in those areas highlighted in Figure A3, it is advisable to take the following precautions:

- Gloves should be worn when contact with the soils is possible;
- Any soil that is attached to clothes, boots, etc., should be removed before they are taken indoors;
- There should be no eating, drinking or smoking when working in contact with the soils;
- Any contractors employed to undertake works involving excavation in the future should be shown this document so that they are aware of the precautions that they should adopt.
- If any building or excavation works that may extend deeper than 600mm below ground level in the rear garden areas are planned, South Oxfordshire District Council must be contacted for advice.
