Cuxham Conservation Area Appraisal

3.0 Summary of Special Interest

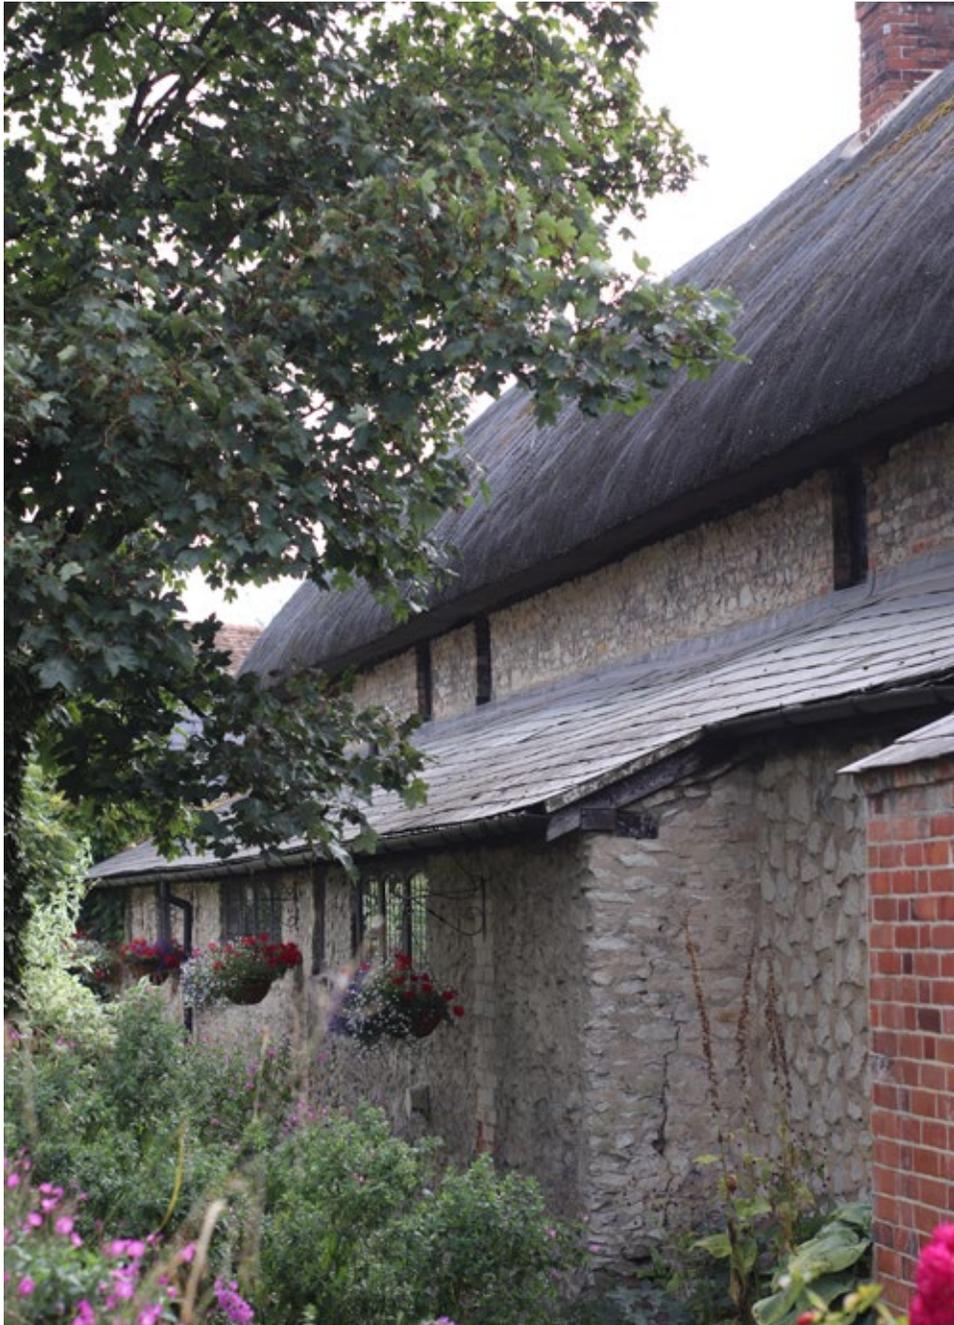
Fig 4. The Old Row House

The agricultural boom in the mid 19th century saw an influx of new residents with a recorded population of 244 in 1841. The major additions of this period include the Old Row House; a row of six cottages built to house the poor (see, Fig 4). Nearby, and contemporary to the row house, is the former National School, today the church hall (above, Fig 10). Both buildings are sited on what was once the Upper Green. The contrast between these two buildings exemplifies the difference between the vernacular and national architectural styles of the period.

College Farm House. The most dense housing was located in the Old Row House, once a terrace of six one-up-one-down dwellings. Five of these were converted into a single residence in 1963.

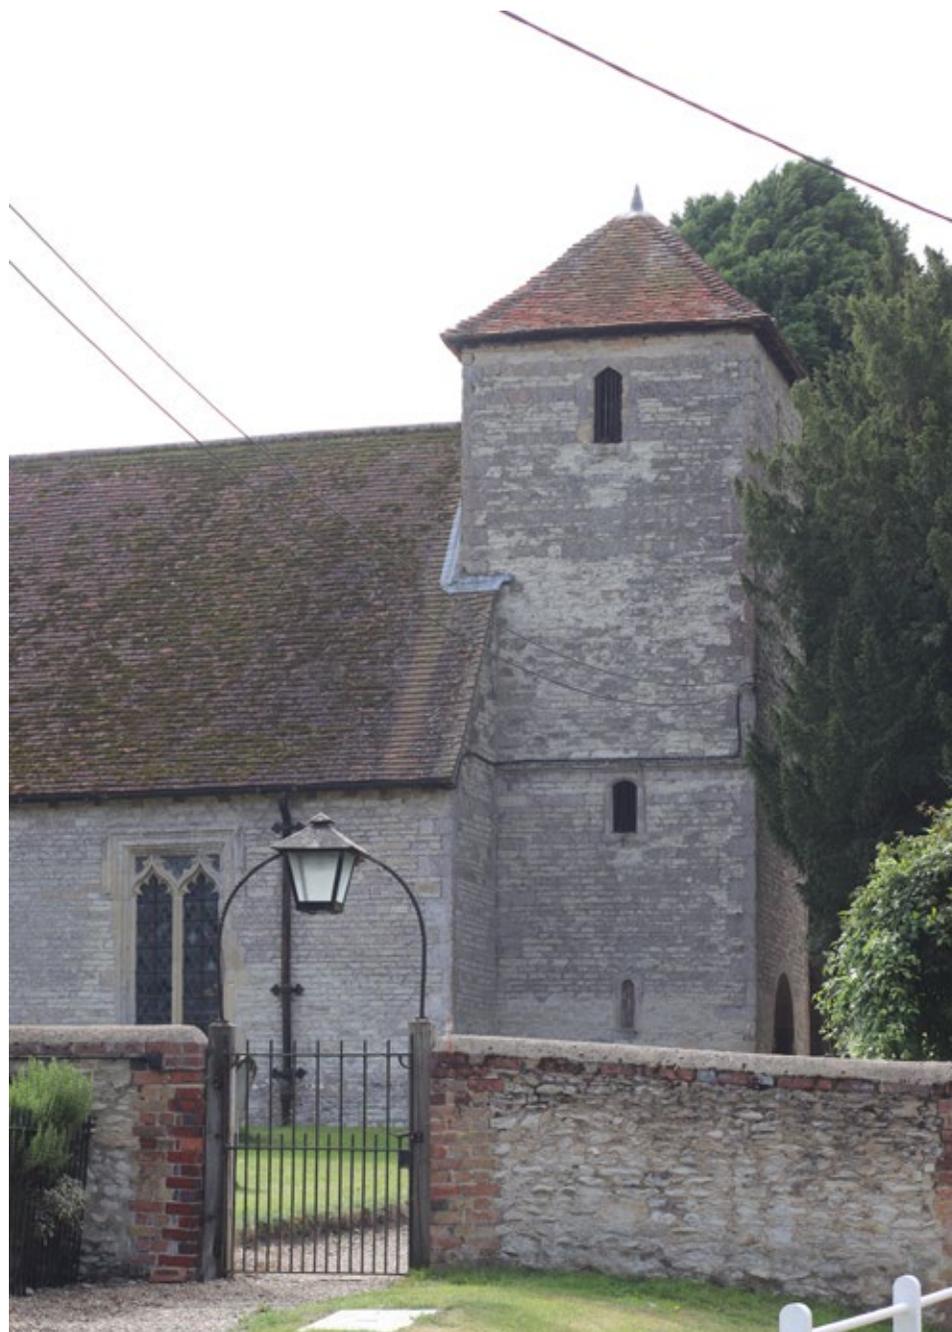
Fig 5. Church of the Holy Rood

Built in the 12th century, the Church of the Holy Rood (see, *Fig 5* and below, *Fig 7*) is the oldest standing building in Cuxham. Though refurbished and partly rebuilt in the 18th century, the church retains the majority of its Norman fabric.

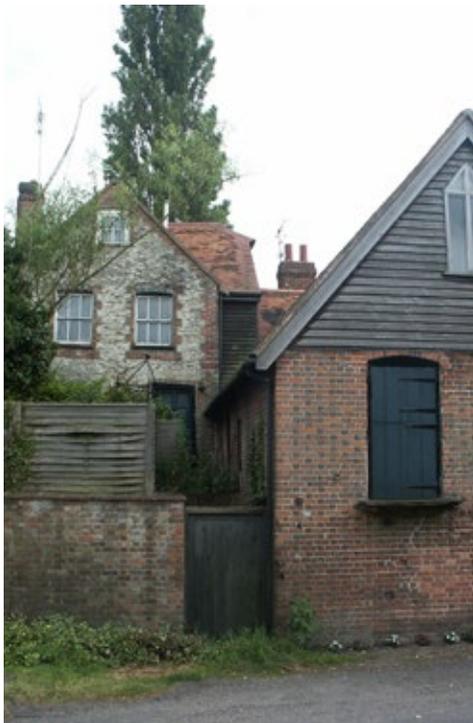
Fig 6. Cuxham Mill

Cuxham Mill (below, *Fig 6*), at the eastern end of the village, is mentioned in the Domesday Book along with the Cutt Mill (north of the conservation area) and one other now lost. The brick wheel house of Cuxham Mill dates from the mid-18th century, though the stone rear block could be earlier.

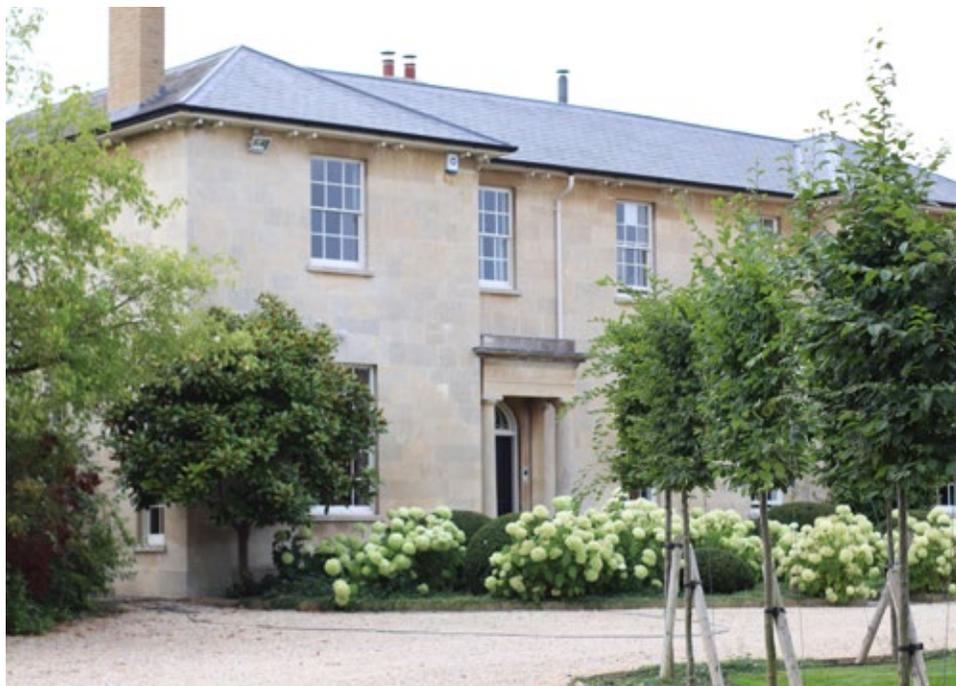
Fig 9. The Old Rectory

The only fully realized 'polite' example of architecture in the village is the Old Rectory (left, Fig 9); rebuilt in its current form in 1823. The late 19th century saw the addition of four handsome semi-detached brick homes in the western end of the village, opposite the Manor Farm.

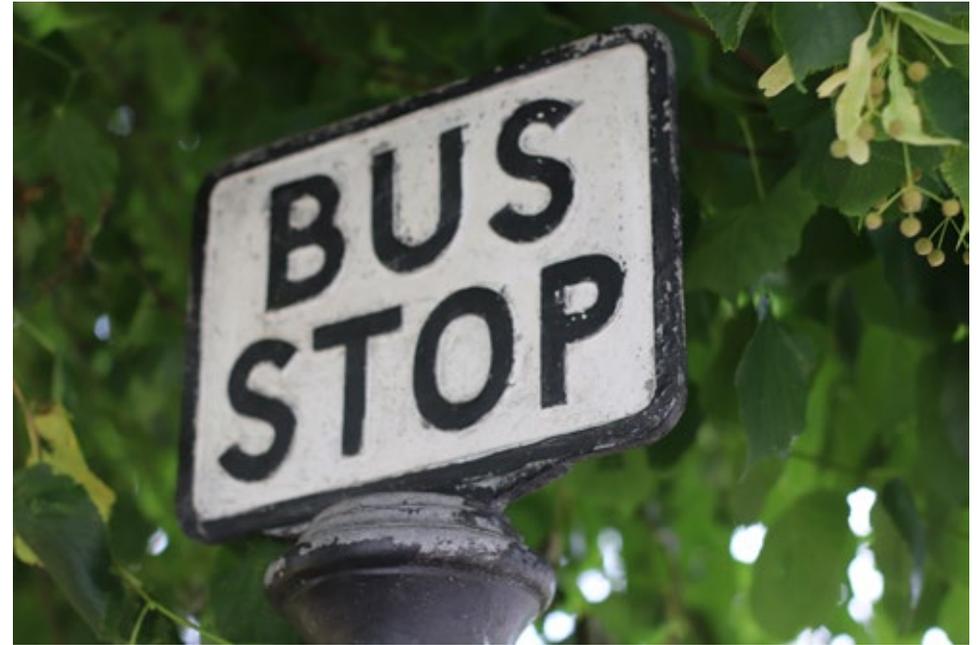
Fig 13. Cast iron bus stop sign, one of several in the village

Cuxham is served by an hourly bus, the city11, by the Oxford Bus Company. The village has a complete set of cast iron bus stop signs (right, Fig 13)

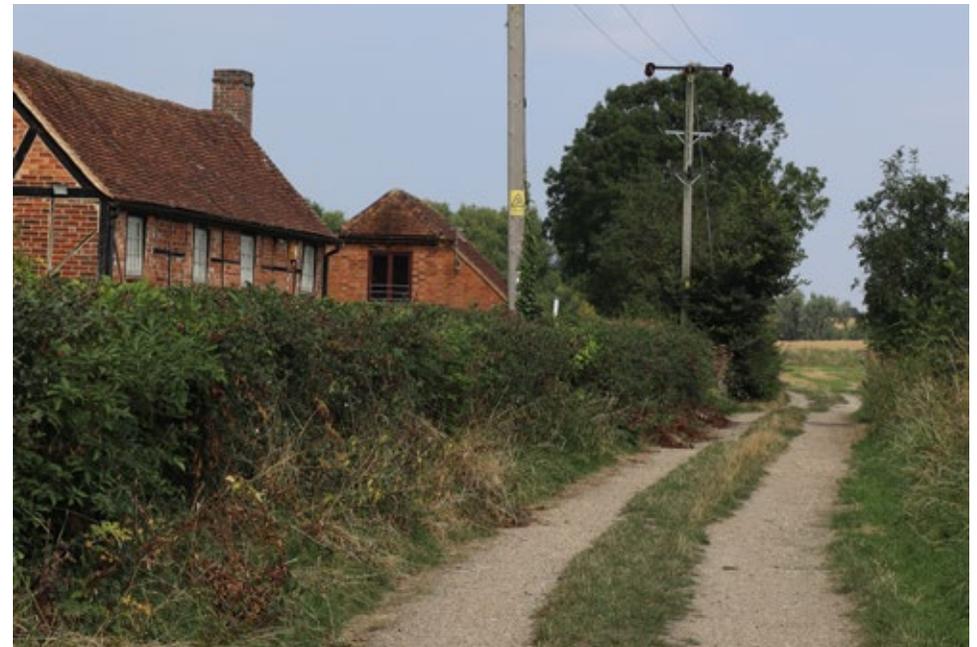
Fig 14. The track through Lower Green towards the common. Lower Green Cottage on the left

The Manor Farm and The Holy Rood can be accessed by a short paved drive crossing the Marlbrook. Cuxham common is today in private ownership but can still be viewed from a bridleway along its east side leading to Easington to the north and Pyrton Heath to the east (right, Fig 14).

Wheelwrights (below, *Fig 17*), likely the largest half-timbered building in Cuxham, has had all of its panels replaced with brick infill, some laid in herringbone. Not to be missed is the similarly brick infilled Lower Green Cottage, which has an attractive eastern facade visible from the track leading towards Cuxham common (see, *Fig 14*).

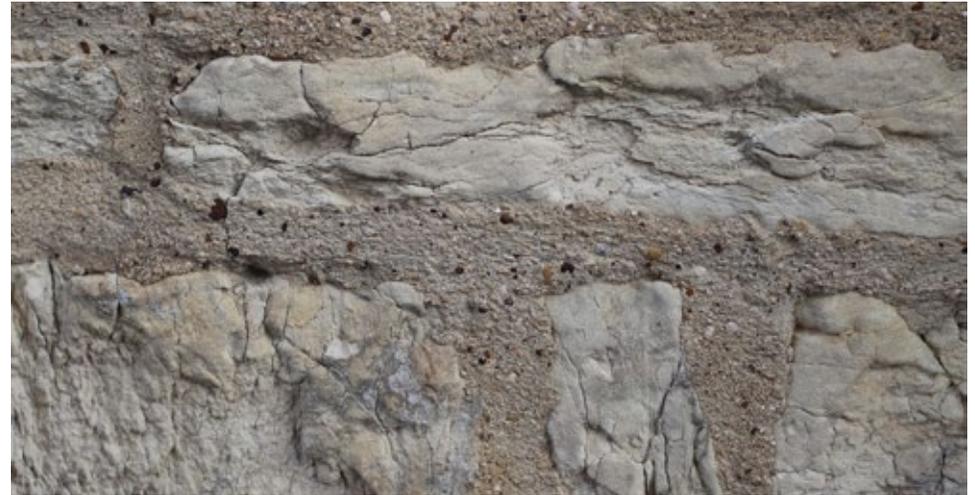
Fig 16. Chalk clunch wall and lime mortar

Cuxham is situated on the border between the Lower Cretaceous Gault formation (clay, mudstone) and the Upper Cretaceous Grey Chalk subgroup. This placement results in a local abundance of chalk clunch (right, *Fig 16*); plentiful but notoriously difficult to use as a building material. The stone cannot be easily shaped and weathers very poorly. Most masonry constructions in Cuxham use chalk clunch in tandem with brick dressings which provide greater stability and erosion resistance. The listed road-facing coach house and boundary wall of The Old Rectory displays an exemplary array of locally employed chalk clunch masonry techniques (below, *Fig 15*). The Holy Rod is built primarily in chalk clunch (both rubble and coursed) but affords the use of Portland and marlstone dressings instead of brick. The Half Moon Pub and the Old Rectory Cottage are the only chalk buildings with unreinforced corners and reveals; stability to openings is instead provided by embedded timber lintels. Several stone buildings, especially those in the eastern end of the village, are whitewashed.

- 7.2.3 Specify appropriate stone materials. As explained in section 5.4 the Cuxham vernacular employs a grey chalk limestone (aka. clunch) for most of its historic construction. This stone should be matched like for like in repairs or rebuilding of any and all parts of existing historic buildings. That said, the council recognizes that clunch is a very difficult material to work with and would therefore be amenable, especially in the case of new buildings, to the specification of harder limestones with greater durability provided they weather to a similar gradient as the historic vernacular.

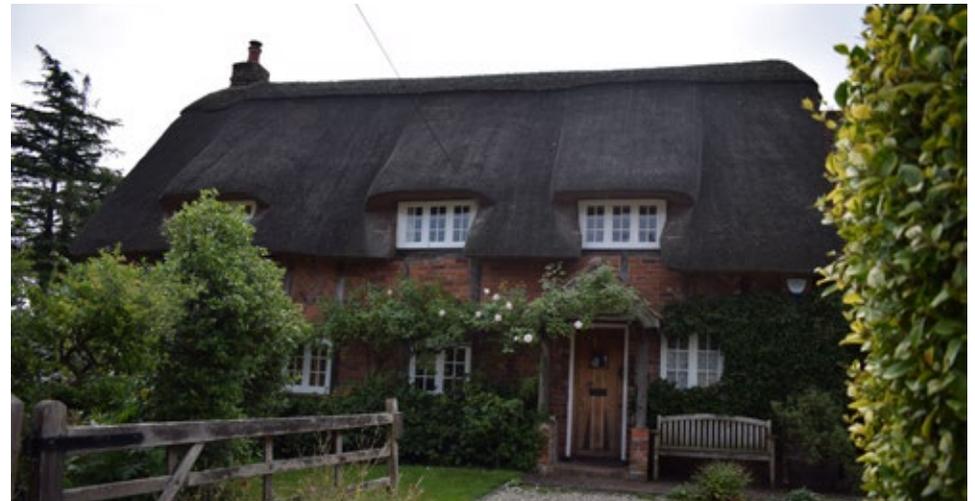
Fig 17. Wheelwrights

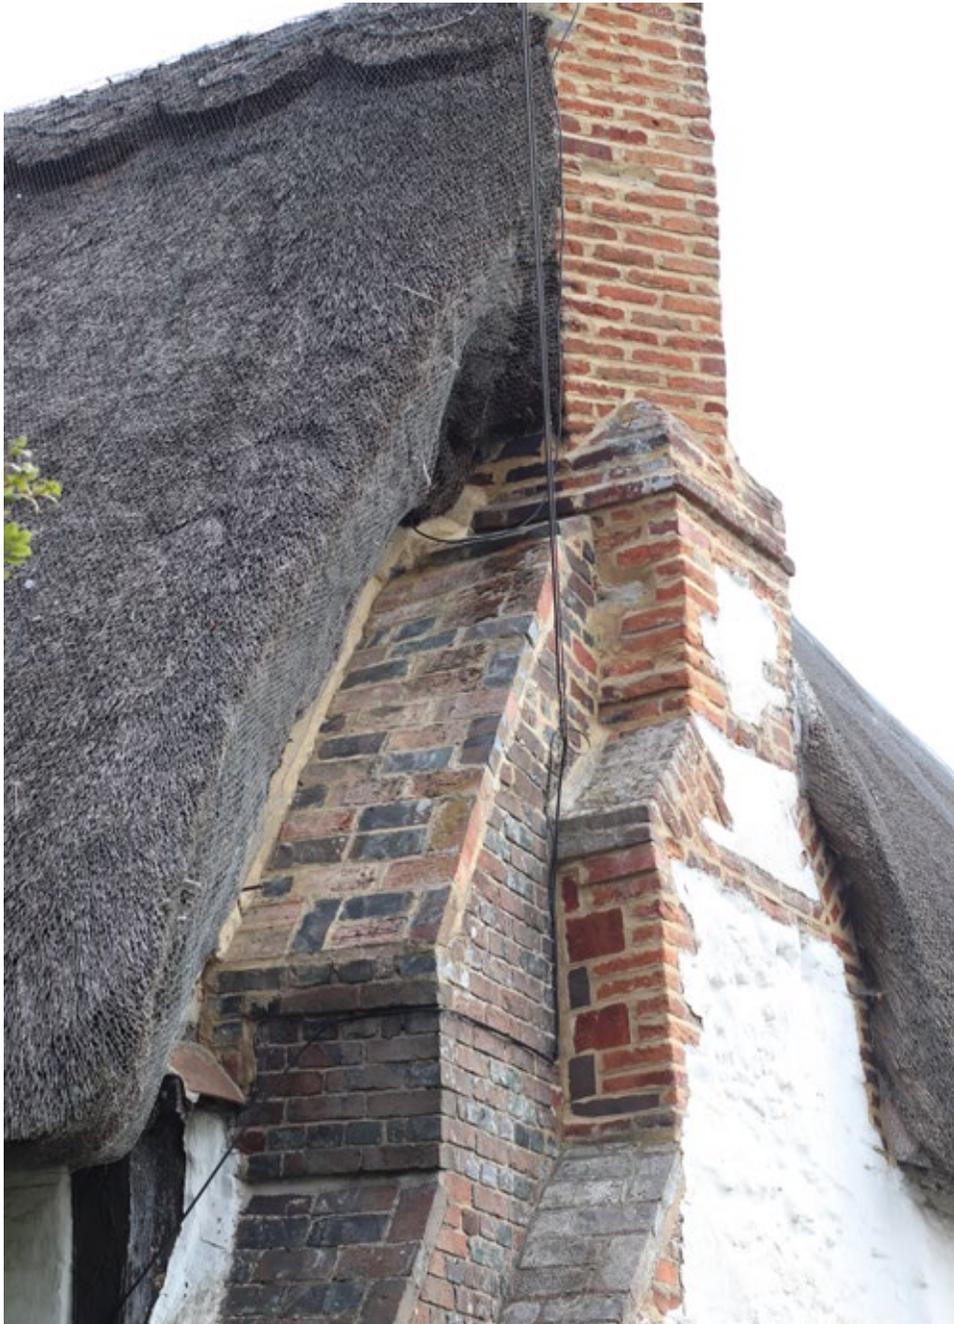
Fig 18. A variety of building materials and techniques on the road facing gable end of The Thatch

Cuxham should be especially noted for its high proportion of thatched roofs. The buildings sporting these, west to east, are: The Thatch, The Old Rectory Cottage, Old Row House, Wheelwrights, Brook Cottage, and the Half Moon Pub. Of these, The Thatch has an ornamental scallop block ridge, the others are flush (left, *Fig 18*).

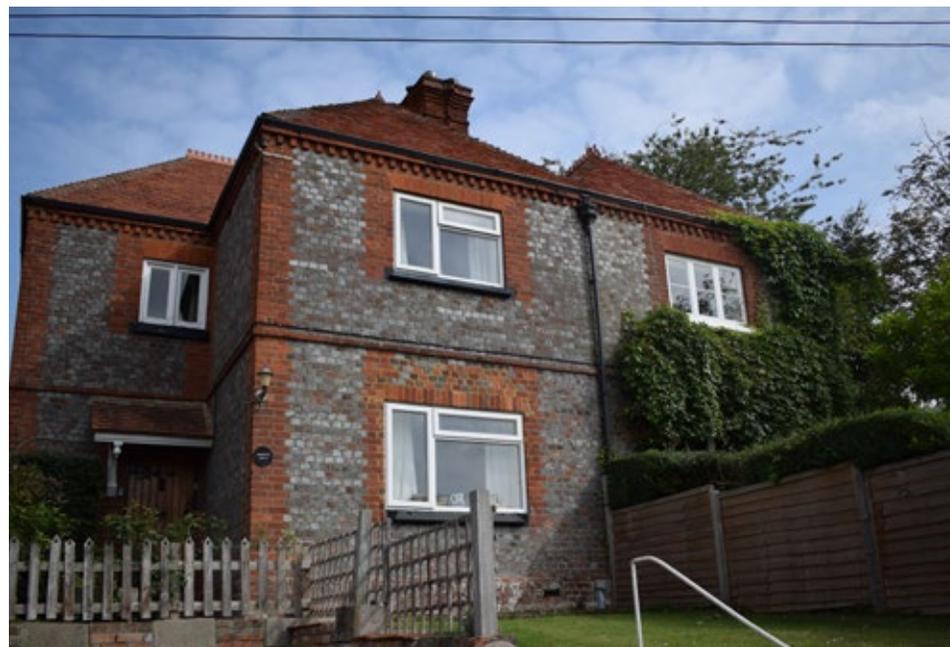
Fig 28. Dharwar Villa, which has had its original casement windows replaced

- 7.2.2 Preserve those features of consistent historic detail, pattern and character that contribute positively to local distinctiveness. This includes the repair, retention, or reinstatement of original windows, doors, stained glass, paving tiles and boundary treatments;

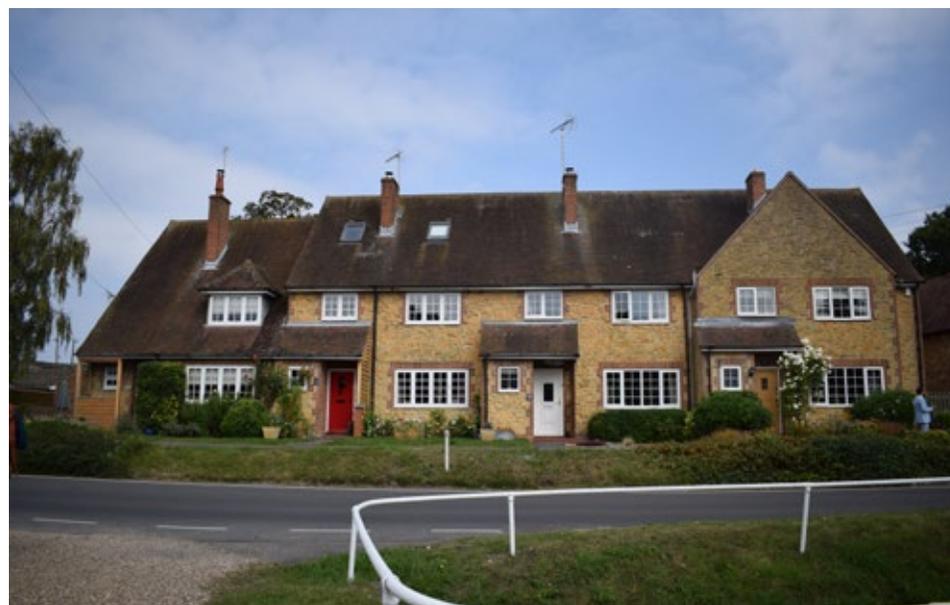
Fig 29. The Merton College Cottages (built 1976) are outside the CA but feature in the streetscape. An inappropriate iron-rich facing stone was used which has weathered to a dark yellow

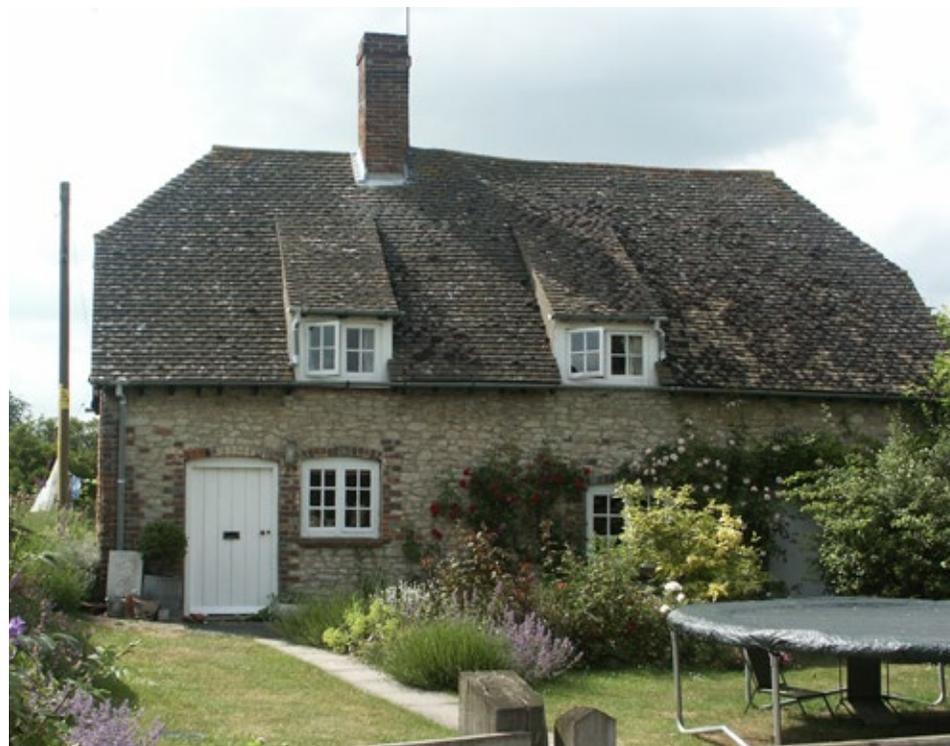
Chestnut Cottage, late 17th century

This cottage, built on the corner of the Manor Farm near Oxford Road, bears all the hallmarks of late 17th century vernacular construction in Cuxham: a central chimneystack, rubble coursed chalk clunch and brick dressings. The long sloping eyebrow dormers indicate the building was once thatched. Added for historic and group value.

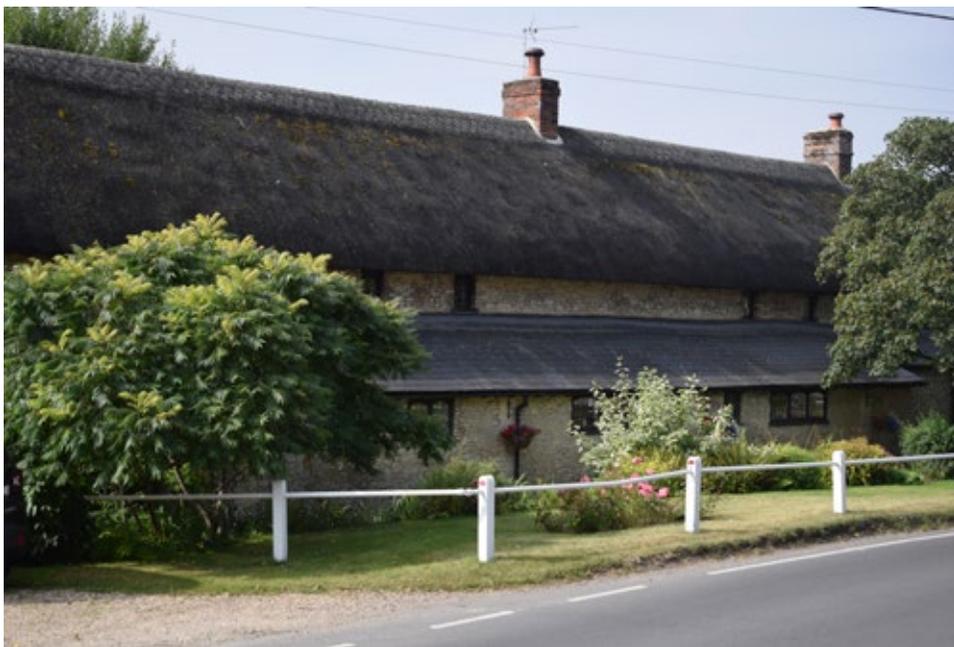
Old Row House, early 19th century

This building, formerly five terraced cottages, was built for the housing of the poor until 1850. The building features prominently in the dynamic views of Oxford Road through Cuxham, owing to its long thatched roof. The grey slate covered lean-to extension along its length, visible above, is a later addition from the late 19th century. This extension is notable as its footings extend into and below the waterline of the adjacent Marlbrook. Added for historic, group and communal value.

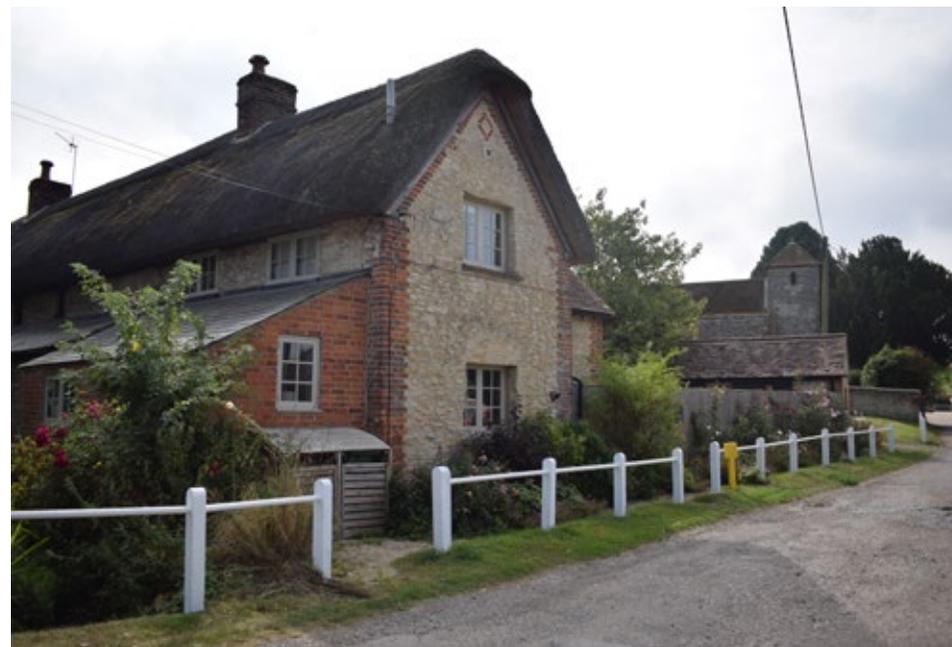
Marlbrook Cottage, early 19th century

This cottage, joined with and contemporary to the Old Row House, was the former church cottage for the housing of the parish clerk, and later sexton. It was sold off as a private residence in 1978. The lean-to was extended to make a more spacious kitchen around the same time. The extension to the south, identified by its clay tiled roof, appears to date from the early 20th century. Added for historic, group and communal value.

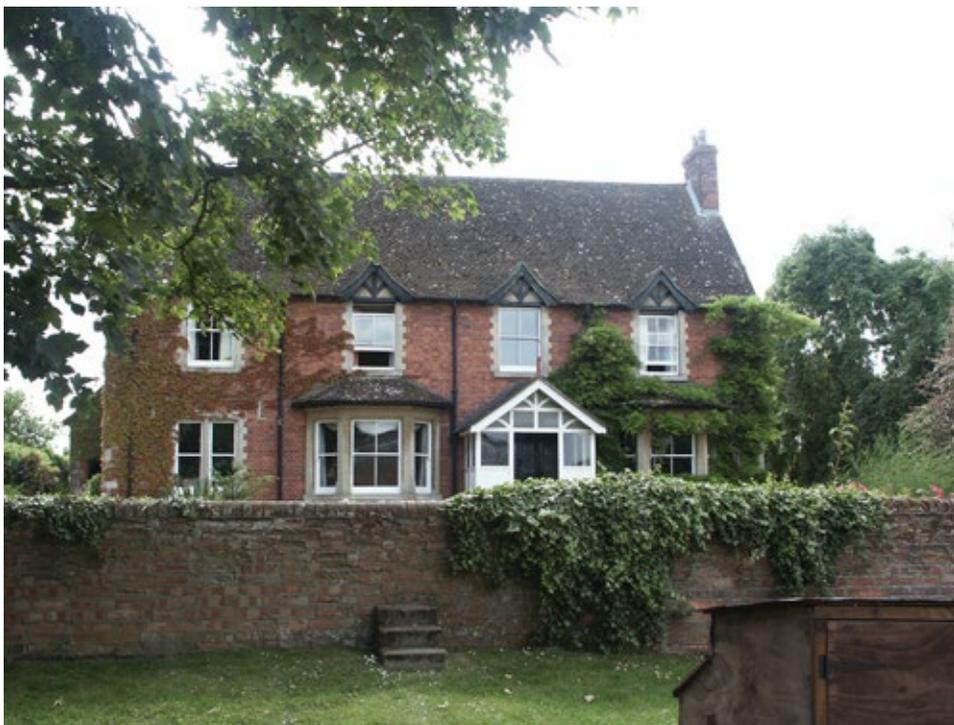
Manor Farm House, parts 13th century, rebuilt 20th century

Though very little of the once impressive 12-hearth Manor House remains, the current iteration still offers the conservation area an idea of the arrangement of the manor farm complex. The present facade (above) post-dates an extensive fire at the turn of the century which saw most of the structure rebuilt, the latest alteration in a series of 19th century rebuilding work. The property would benefit from an archaeological study to understand which parts of the historic manor house are buried in the garden and remain behind later rebuilding. Added for historic value and archaeological potential.

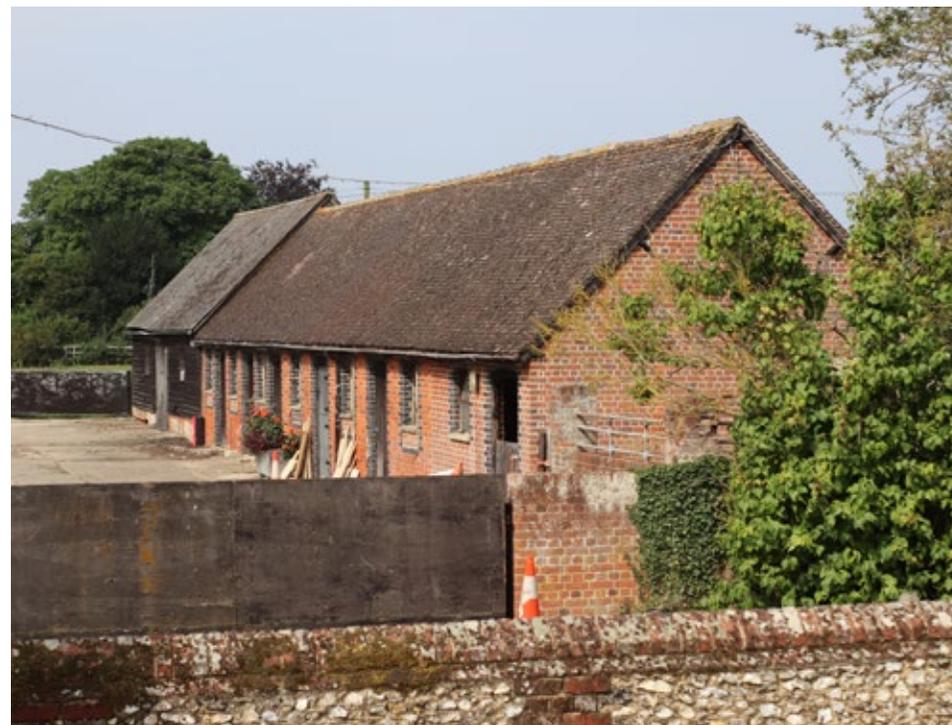
Manor Farm Stables, mid 19th century

These stables, which are the oldest extant agricultural outbuildings besides the listed granary, have been partly rebuilt, but appear on the earliest OS maps of the manor farm. They are still today used as stables. The rear elevation is an attractive feature of the manor farm when viewed from Oxford Road (see, *Fig 24*). Added for group and aesthetic value.

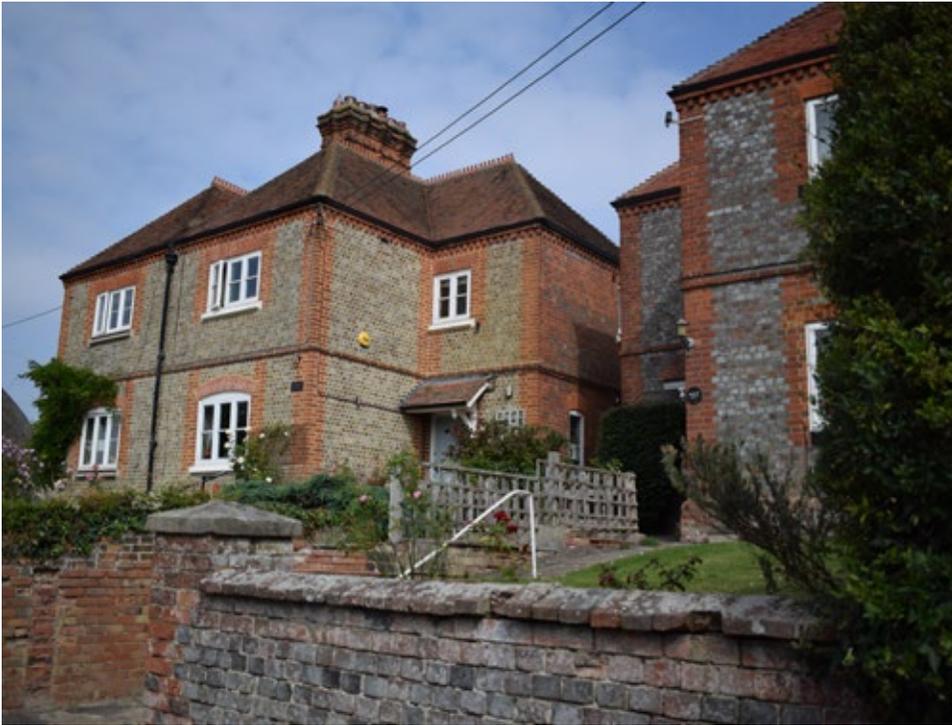
Brightwell Villas, 1874

These four semi-detached villas, all built in the same year, were constructed for the housing of servants employed at Brightwell Park. They are especially unusual for their size and style in contrast to the rest of Cuxham; a reflection of their non-agricultural intentions. Added for historic value.

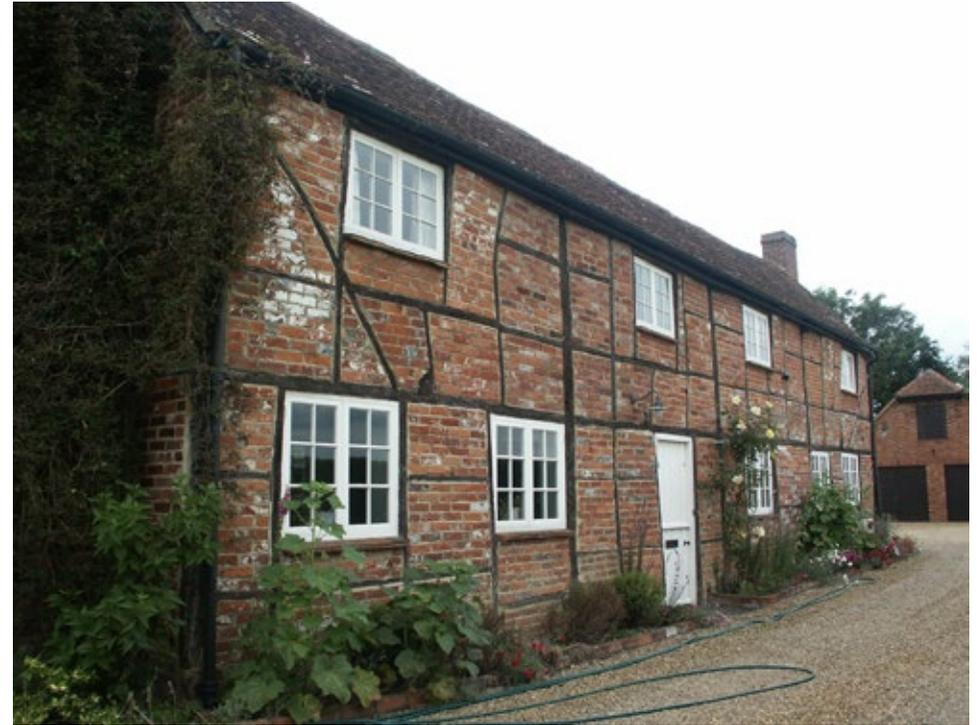
Lower Green Cottage, mid 18th century

The cottage appears on early OS maps as two semi-detached properties with separate gardens. It was likely inhabited by smallholders when it was first constructed around the time of enclosure. The cottage gets its name from the former Lower Green which once existed here. This area of Cuxham once had many more farms and structures for tenant farmers; none of these survive. Added for high historic, aesthetic, and group value.

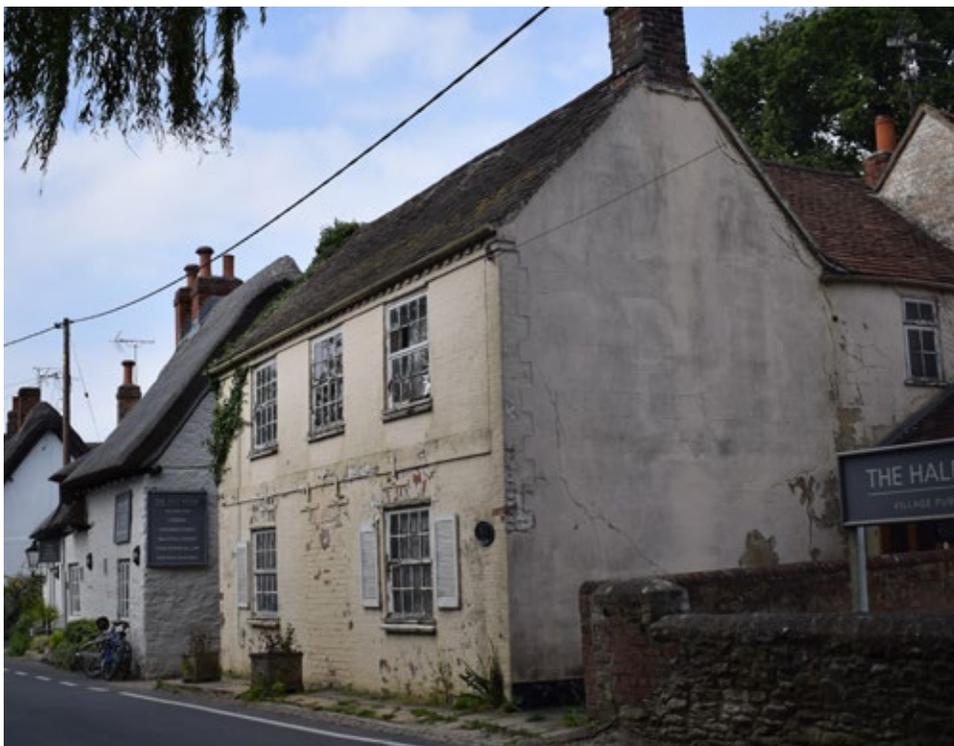
Crescent House, parts late 17th century

The house was once part of the farm complex which the Half Moon Pub was once also a part. Plans indicate the oldest part of the building, fronting the road, has exceptionally thick walls which may be stone, refaced in brick. Parts of the building could be contemporary with the 17th century Half Moon Pub. What is historically known as “The Cottage” is today the rear annex of Crescent House, and likely dates from the period of refurbishment which gave Crescent House its current Georgian appearance. The original front door has been bricked up. Further study into its significance should prove fruitful. Added for historic, evidential, and group value.
